## A Survey of Thatched Buildings in Scotland

Thatch Survey of Scotland  
2014-15

A photographic survey of thatched buildings in Scotland, surveyed between May 2014 and August 2015 by Zoe Herbert (SPAB Scotland Officer), on behalf of the Society for the Protection of Ancient Buildings.

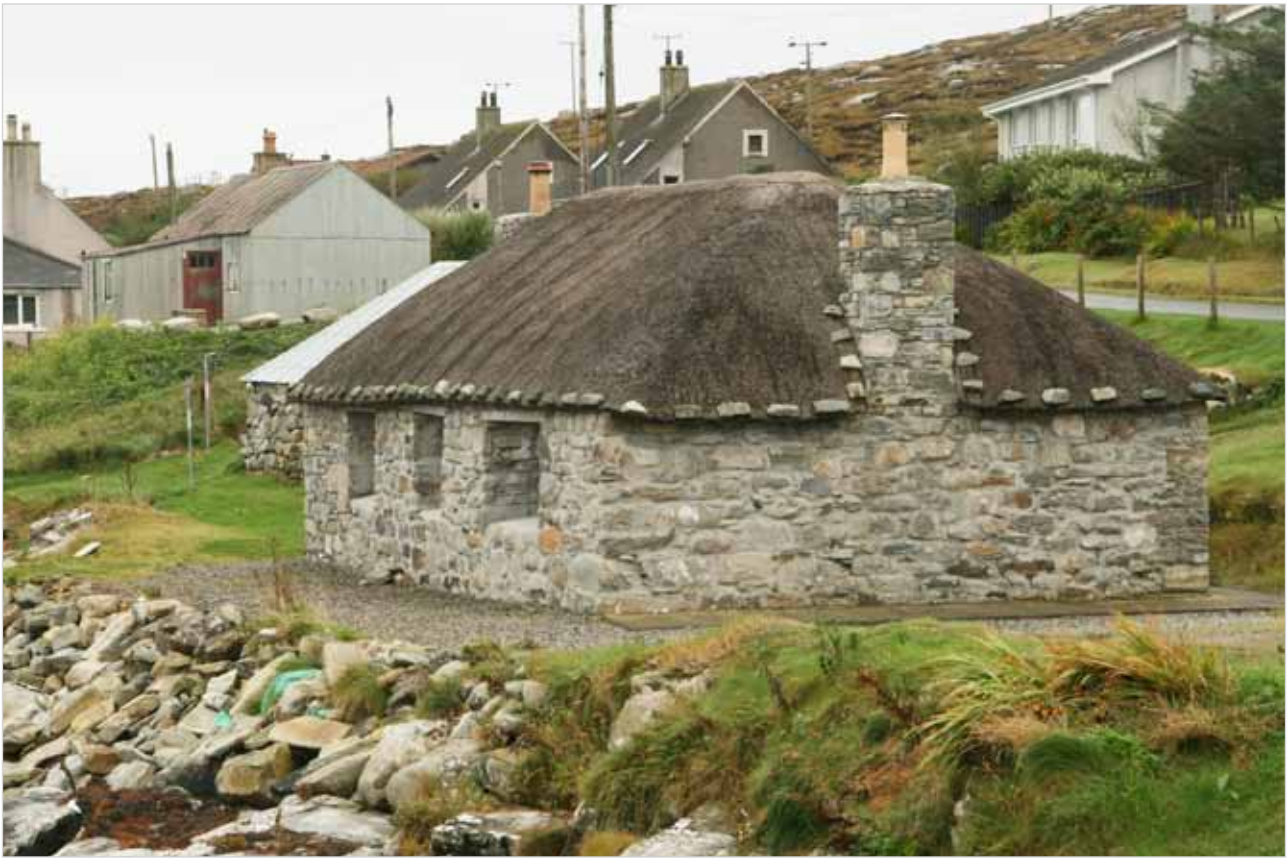
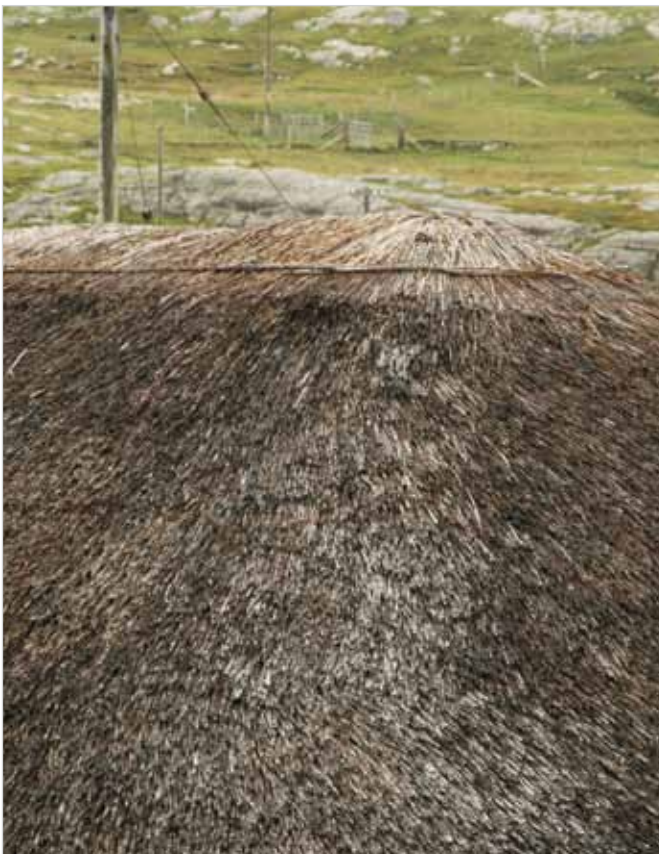
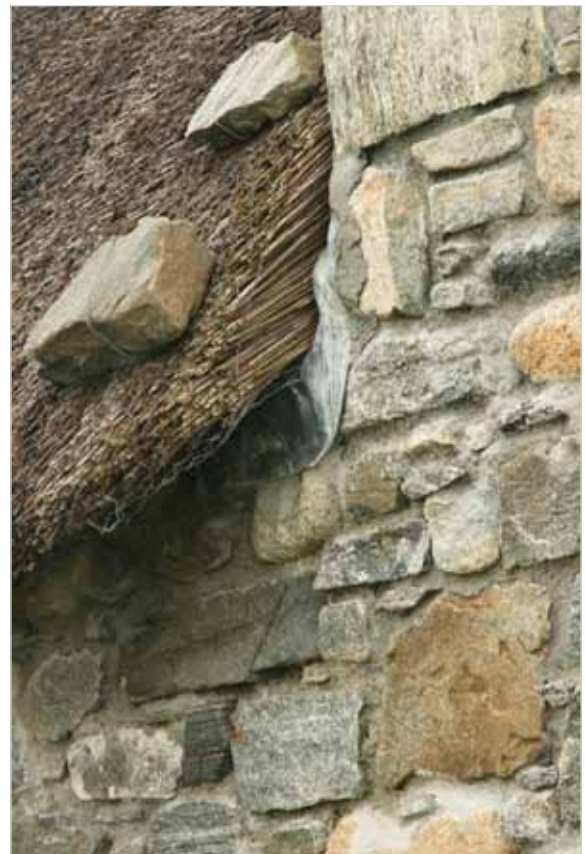
Address: ..... 30 Backhill

Condition of Thatch: ..... Good

Additional Notes: ..... Recently renovated cottage of unknown date, currently in use as holiday accomodation.

The cottage has a reed-thatched roof with a continuous straw ridge. The entire roof has been netted, including across the ridge, which has been weighted just above the eaves and down the sides of the chimney stacks at either end with stones that have been attached to the netting with wire. Along the ridge, and underneath the netting, there is a single horizontal row of sparring securing the top layer of straw thatch in place, which appears to be made from strips of hazel.

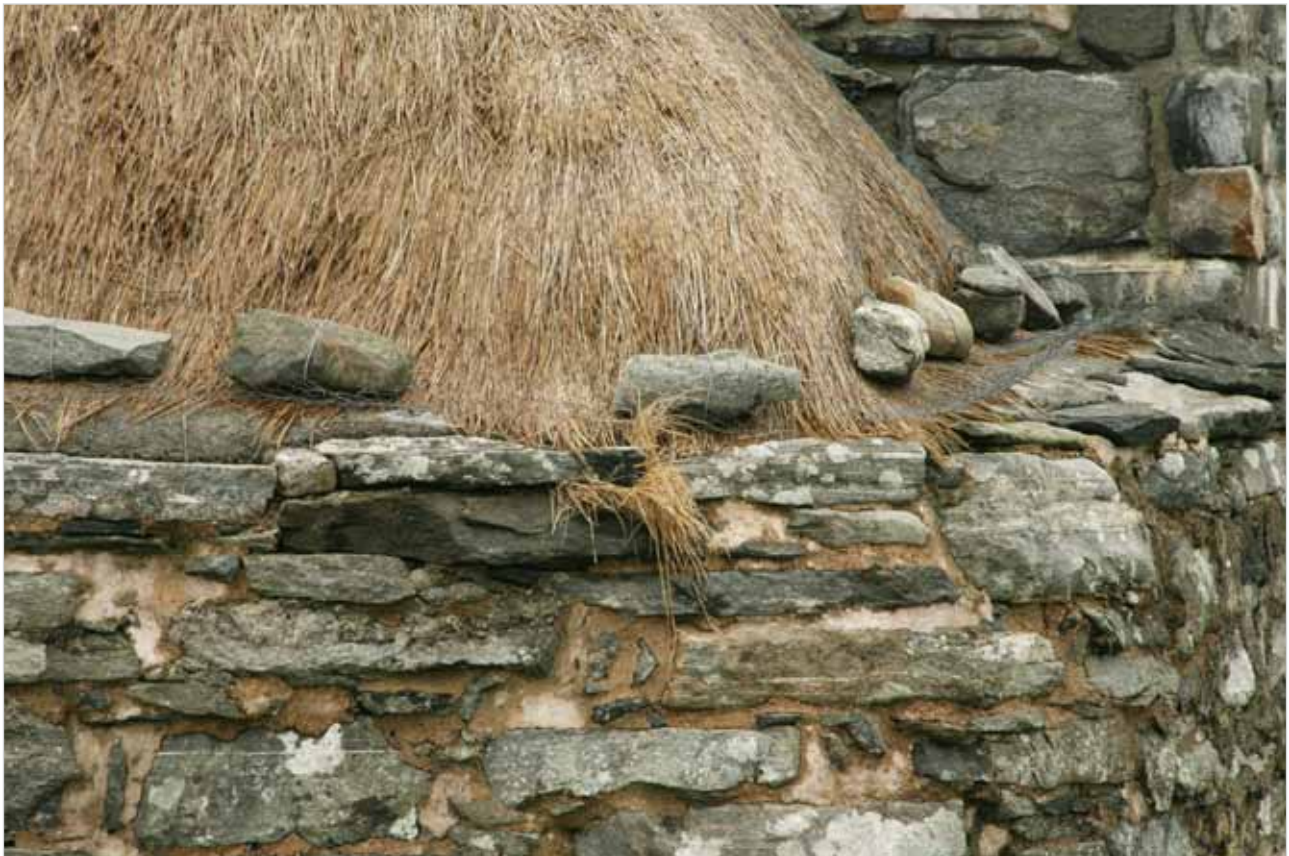
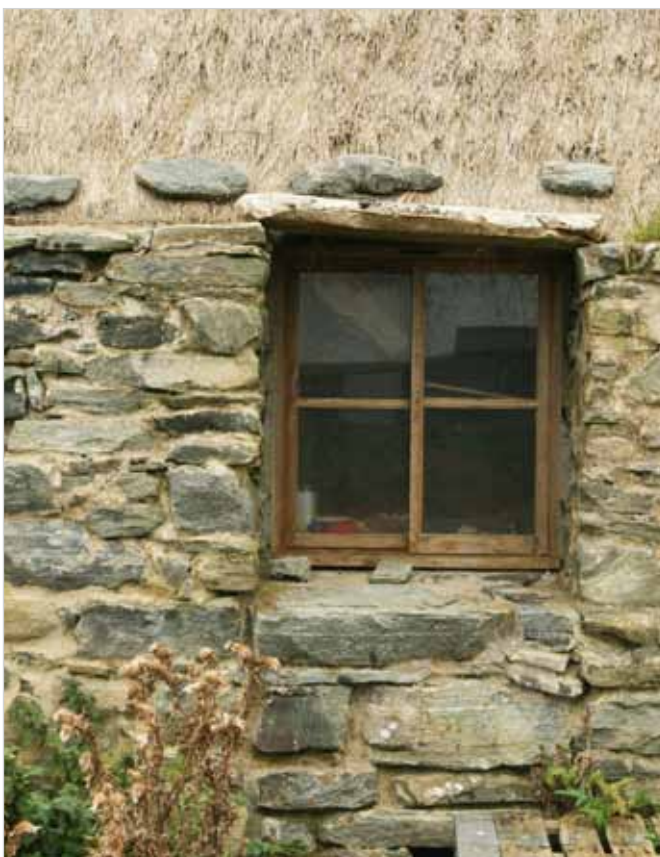
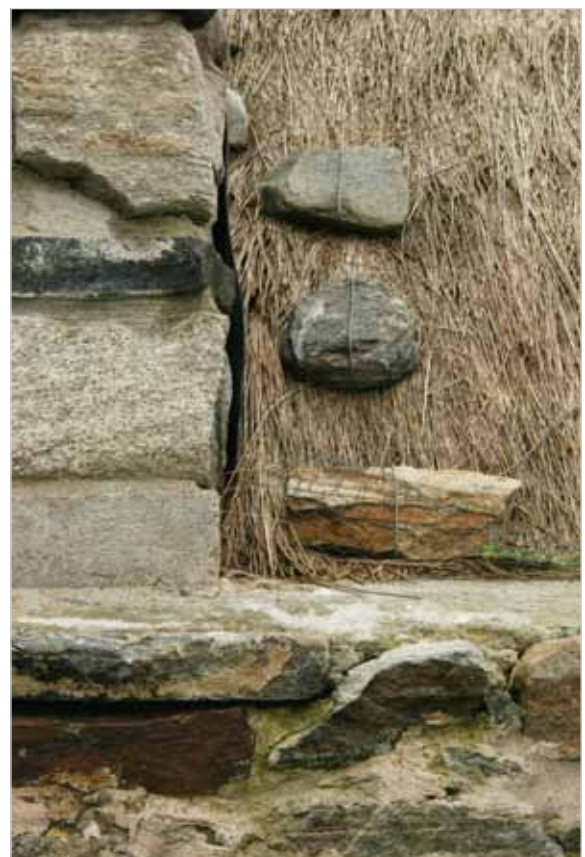
Cnoc an Dundion Thatched Cottage (East Cottage) – Western Isles

Condition of Thatch: Good

**Additional Notes:** Probably 19th-century cottage, listed as having a 'muran thatch roof, secured with ropes and netting, stone weights over inner wall head'. The building has been on the Buildings at Risk (BAR) Register since 1998 (BAR reference number 1856), at which time it was recorded by BAR to be derelict and the roof was collapsing. In 2009, BAR recorded upon inspection that the cottage was a roofless ruin, but by 2010 it was recorded that 'planning permission and listed building consent has been granted for renovation of cottages to provide a residential unit and a studio'. The renovation of the adjacent cottage was complete upon visiting (survey

number 242); however, this cottage is still being renovated internally. It has a marram-thatched roof with a continuous marram ridge. The roof is entirely netted, and weighted along the eaves with stones, secured to the netting by wire. The BAR register and the listing description should be updated accordingly.

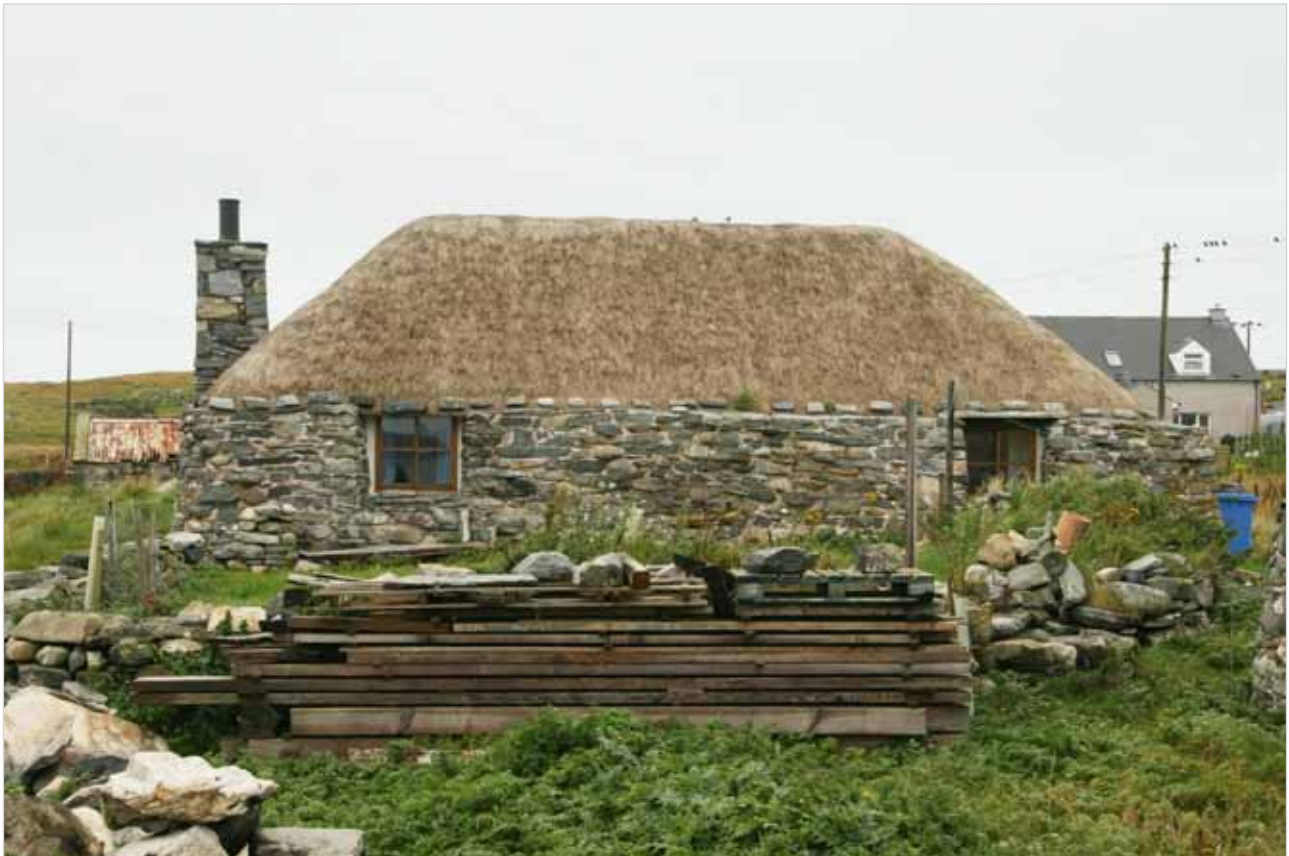
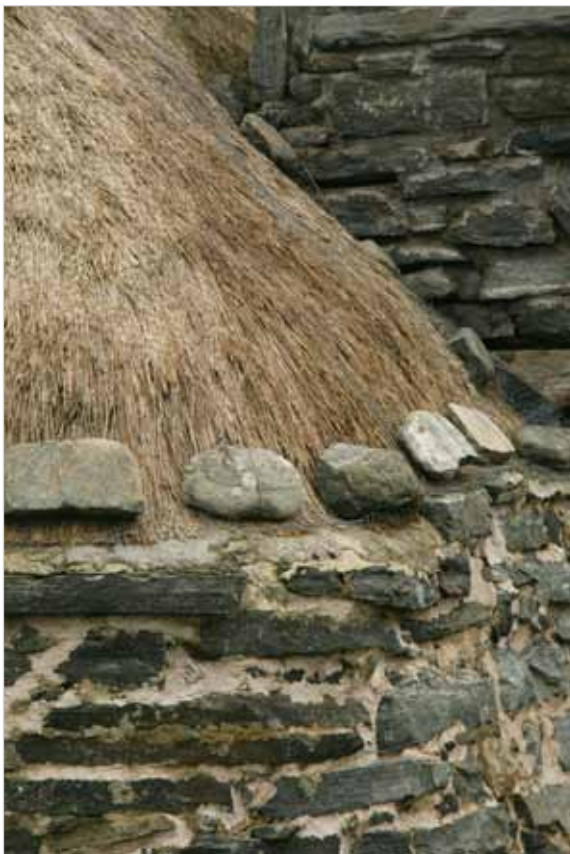
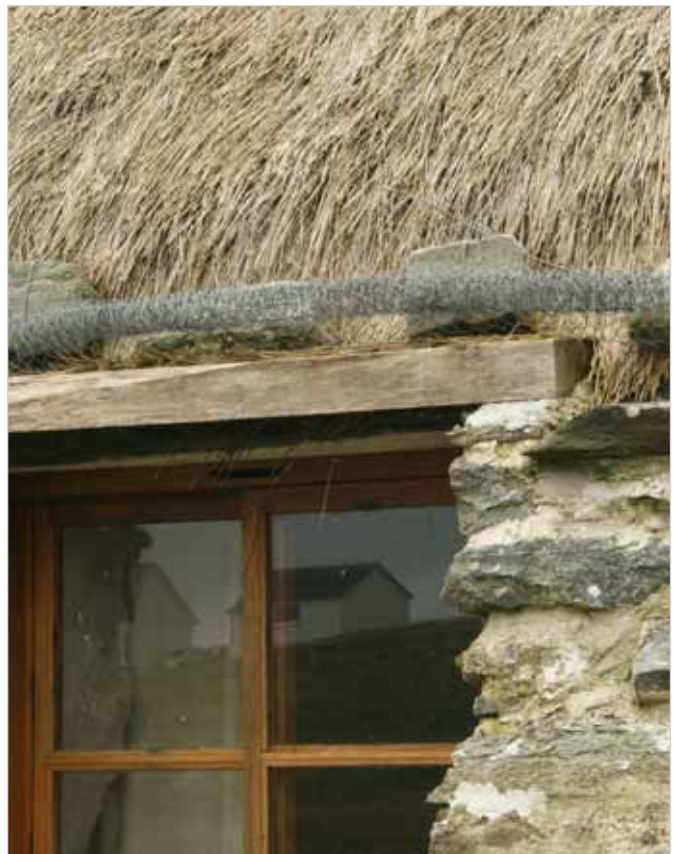
Cnoc an Dundion Thatched Cottage (West Cottage) – Western Isles

Condition of Thatch: Good

Additional Notes: Recently renovated cottage of unknown date, currently in use as holiday accomodation.

The roof is thatched in marram and has a continuous marram ridge. The entire roof has been netted, including across the ridge, which has been weighted along the eaves by stones secured to the netting with wire. The eaves are set back slightly from the wallhead and the weighting stones rest upon the wall in places. Timber boards have been placed above some of the window and door openings to keep the thatch in place.

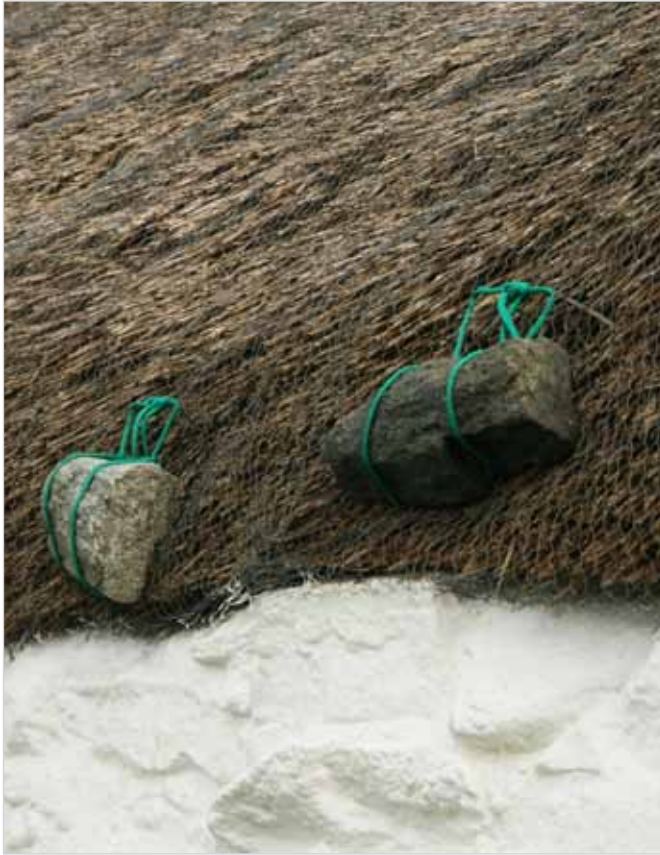
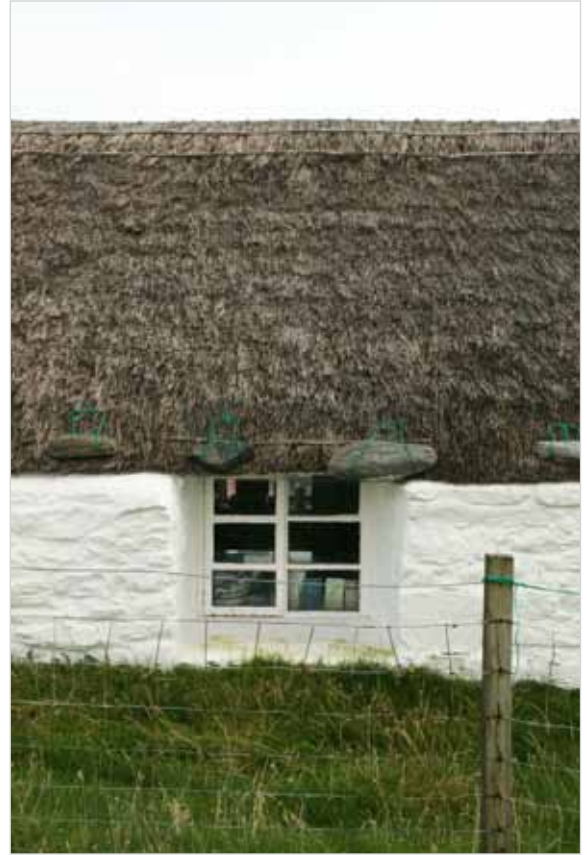
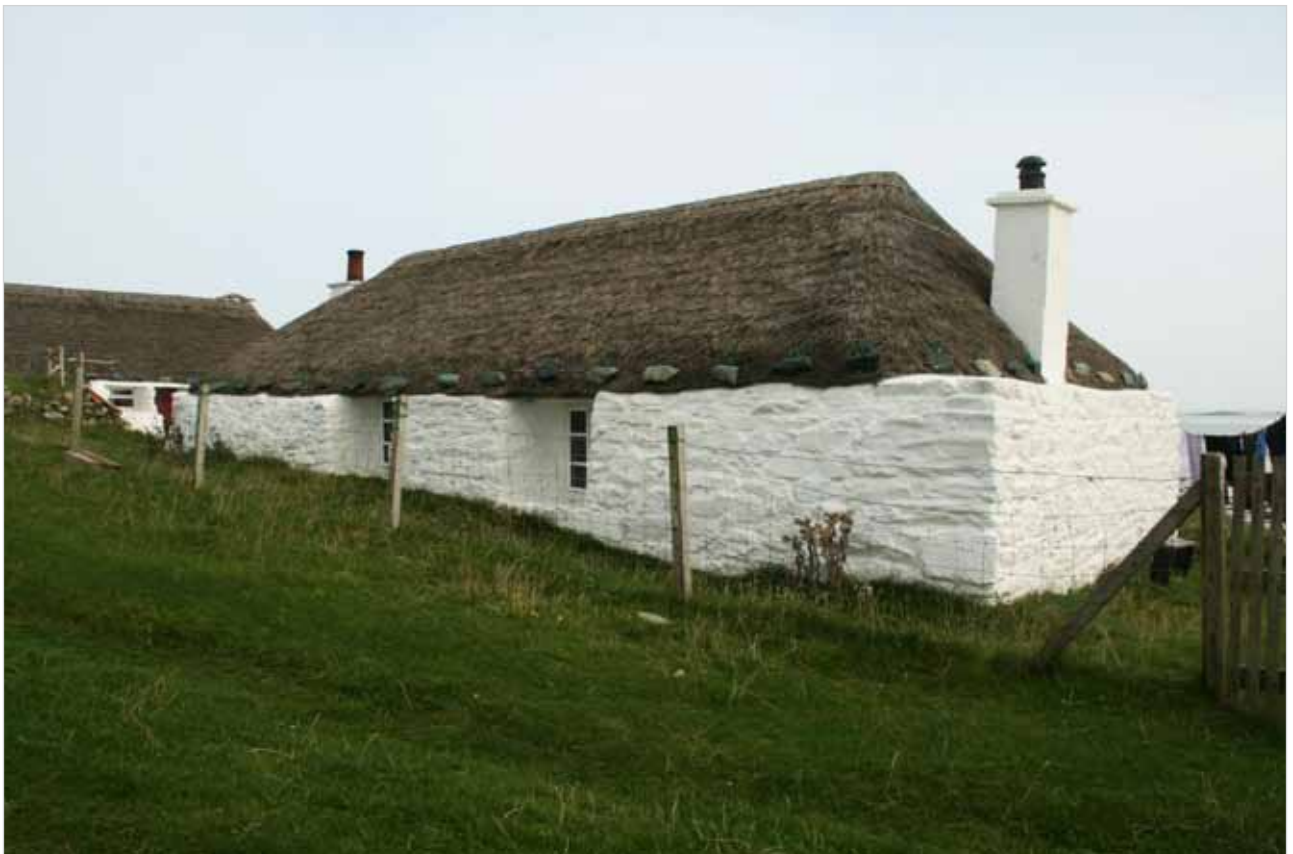
Berneray Hostel – Western Isles

..... Good

exposed. The ridge is scobed with two horizontal rows of hazel spars; however, this has become slightly loose and is partially missing at the ends of the ridge.

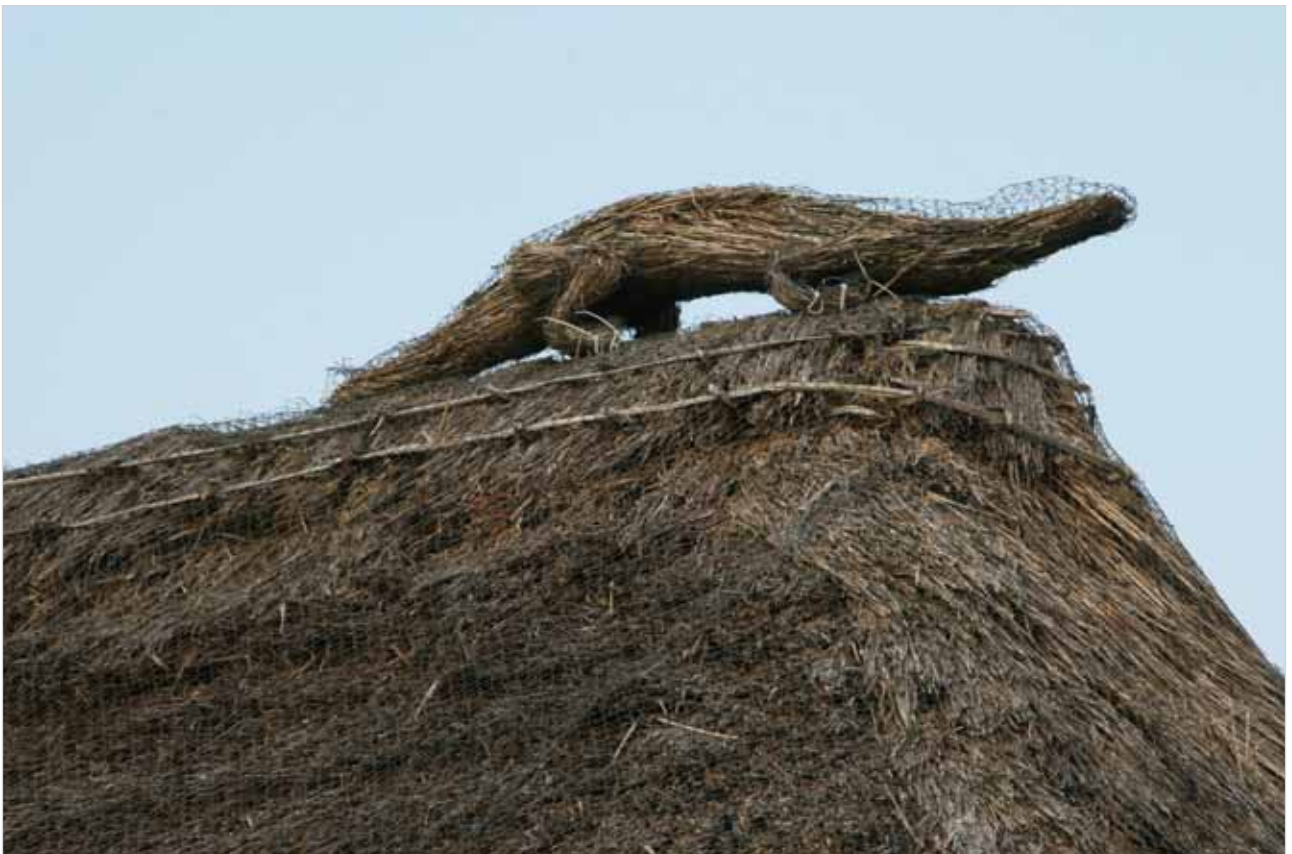
Berneray Hostel Annex – Western Isles

Condition of Thatch: ..... Good

Additional Notes: ..... Used as an annex building for the Berneray Hostel, housing one dormitory, one toilet room and one shower room. It is located a few metres away from another thatched cottage that is also used as part of the hostel. The thatch is netted all over, including across the ridge, and this is held down by stones that are secured to the netting a few inches above the wallhead by string. The thatch comes to the edge of the wallhead, leaving just a few inches of the wallhead exposed in a few places. The thatched ridge is scobed with hazel spars and has a thatched sculpture of an otter secured to the ridge at the south end. Some of the material from the

..... otter sculpture, which is secured in its shape by netting, is missing. The adjacent thatched cottage, which is also part of the hostel, was listed in 1971 as being the north-east end of the settlement; however, the annex is located to the north-east of the main hostel building, making the origin and date of the annex unclear.

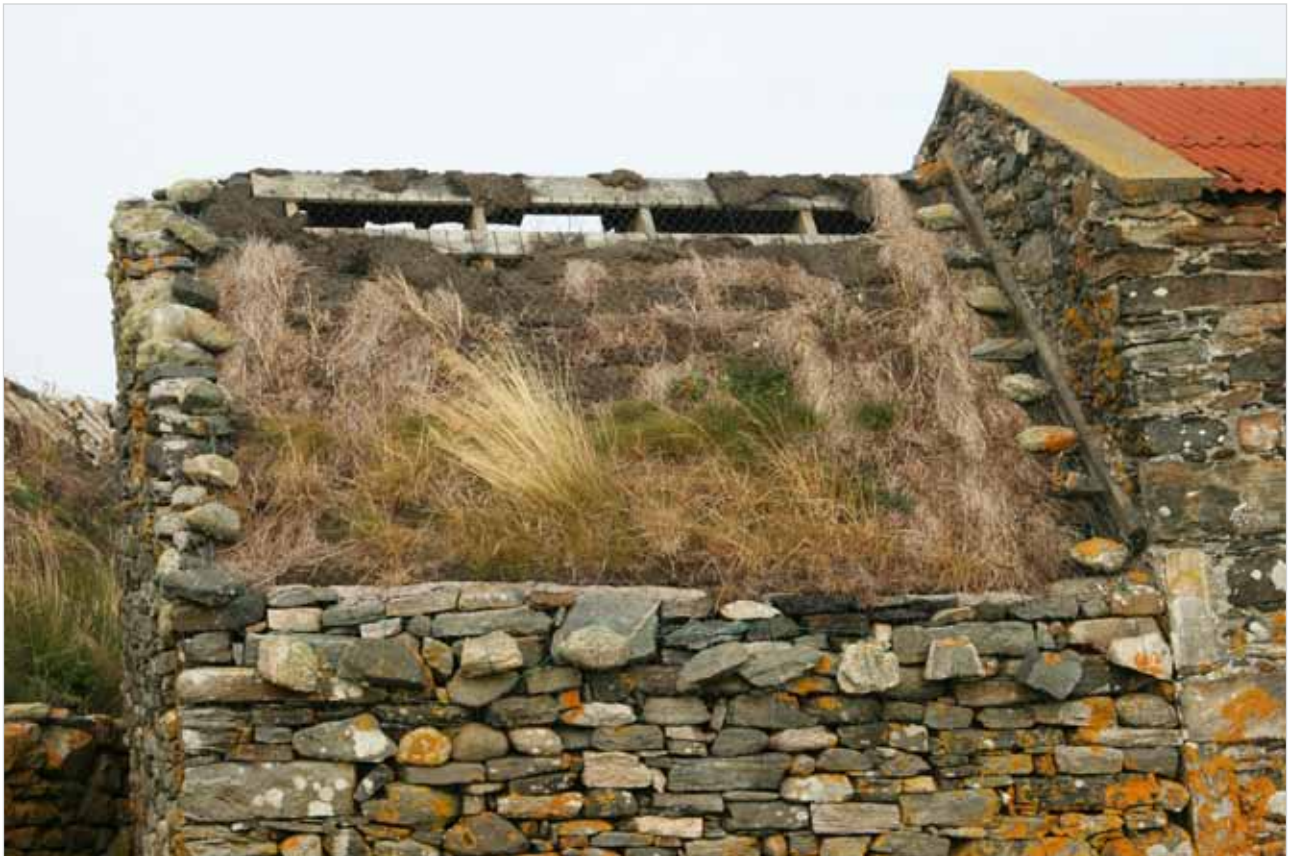
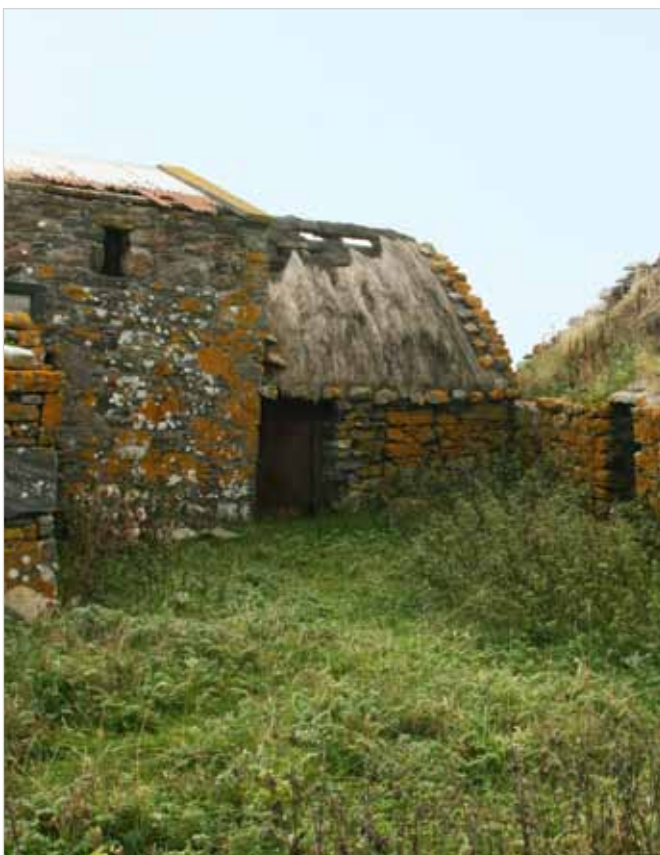
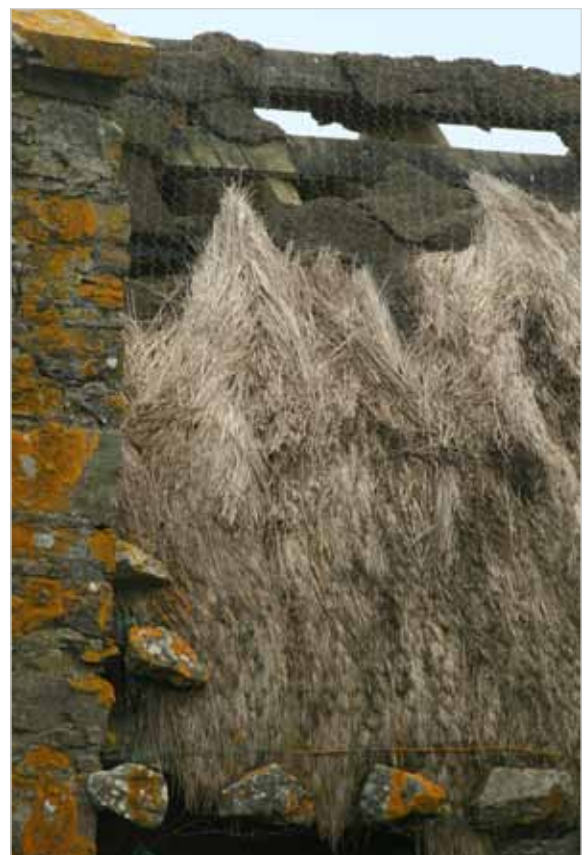
Ruisgarry Barn – Western Isles

Address: ..... Ruisgarry Barn  
..... Baile  
..... Isle of Berneray  
.....  
Local Council: ..... WESTERN ISLES  
.....  
Grid Reference: ..... NF 93225 81516  
Date of Visit: ..... 21/09/2014  
Thatch Type: ..... Marram  
Ridge Type: ..... n/a  
Condition of Thatch: ..... Poor

**Additional Notes:** ..... Thought to be 18th-century, the listed building description reads '*corrugated iron roof (presumably thatched formerly); roofless additions beside door and on north west gable*'. The part of the building that is currently thatched is that described as being roofless. Although some of the marram thatch remains, the building is vacant and in a severe state of deterioration. Much of the thatch is still intact on the north roof pitch; however, there are large holes in the thatch at the top, leaving the interior and the roof structure exposed. The south pitch is missing much more of its thatch and is overgrown with vegetation. None of the ridge remains

and the turf underlay is exposed in many places. The roof remains netted, held in place by stones that are secured to the netting by string along the wallhead and skews. The building is located next to a thatched byre under the same listing (survey number 248). The barn has been on the Buildings at Risk Register since 2009 (BAR reference number 3744).

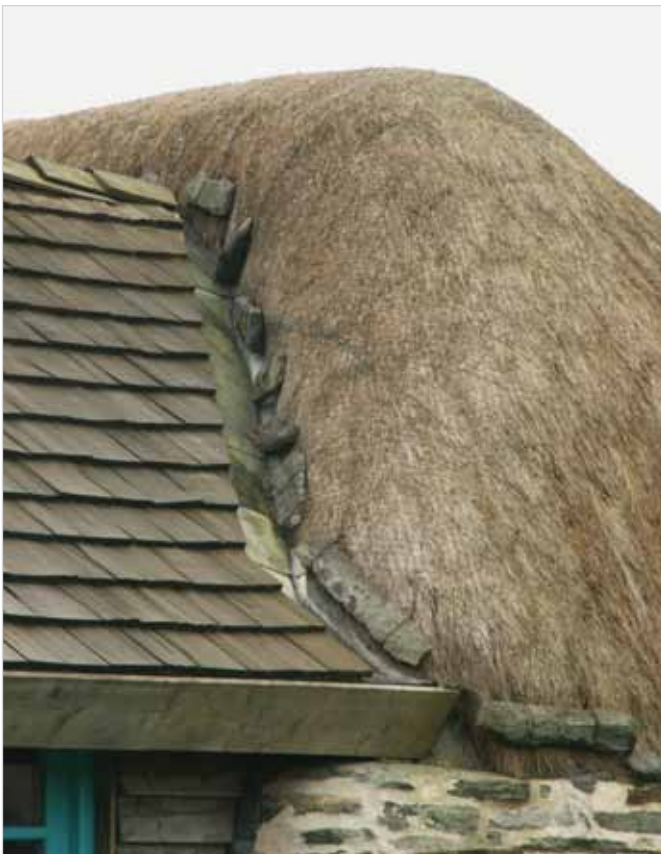
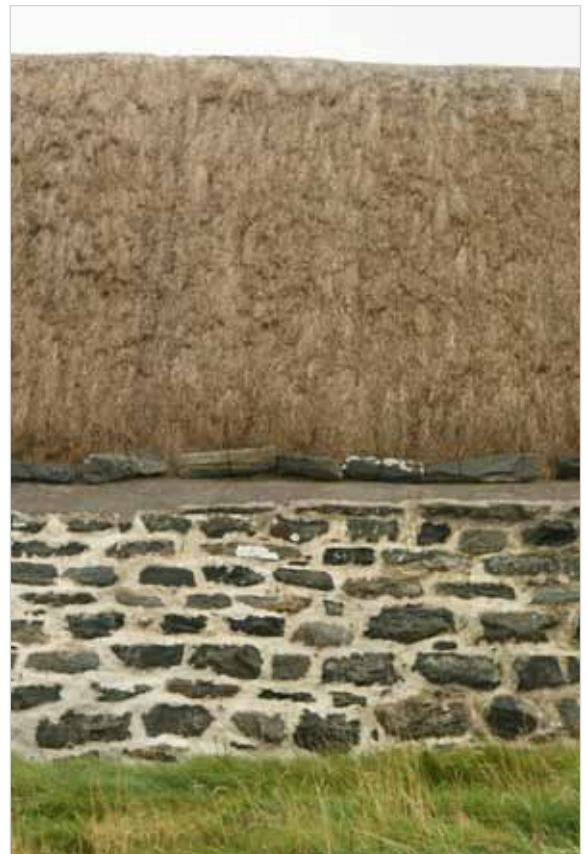
Ruisgarry Byre – Western Isles

**Additional Notes:** Thought to be 18th-century, the listed building description reads '*muran thatch roof, secured with ropes and netting, stone weights over inner wall head [and] pegs on gable head*'. The building is currently vacant and in a severe state of deterioration, particularly the roof which has lost much of its thatch, leaving the roof structure and interior exposed. What is left of the marram thatch and turf underlay is overgrown with vegetation and the ridge has been completely lost. The entire roof remains netted, weighted down by stones and bricks that have been placed on top of the netting along the wallhead and down the skews. There is no

visible evidence of the ropes and stone weights described to secure the thatch and netting in the original listing description, or the pegs at the gable head. The building is located next to a thatched barn under the same listing (survey number 247). The byre has been on the Buildings at Risk Register since 2009 (BAR reference number 3745).

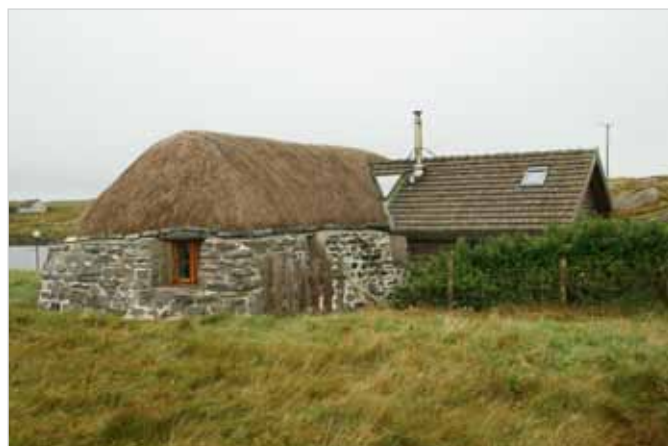
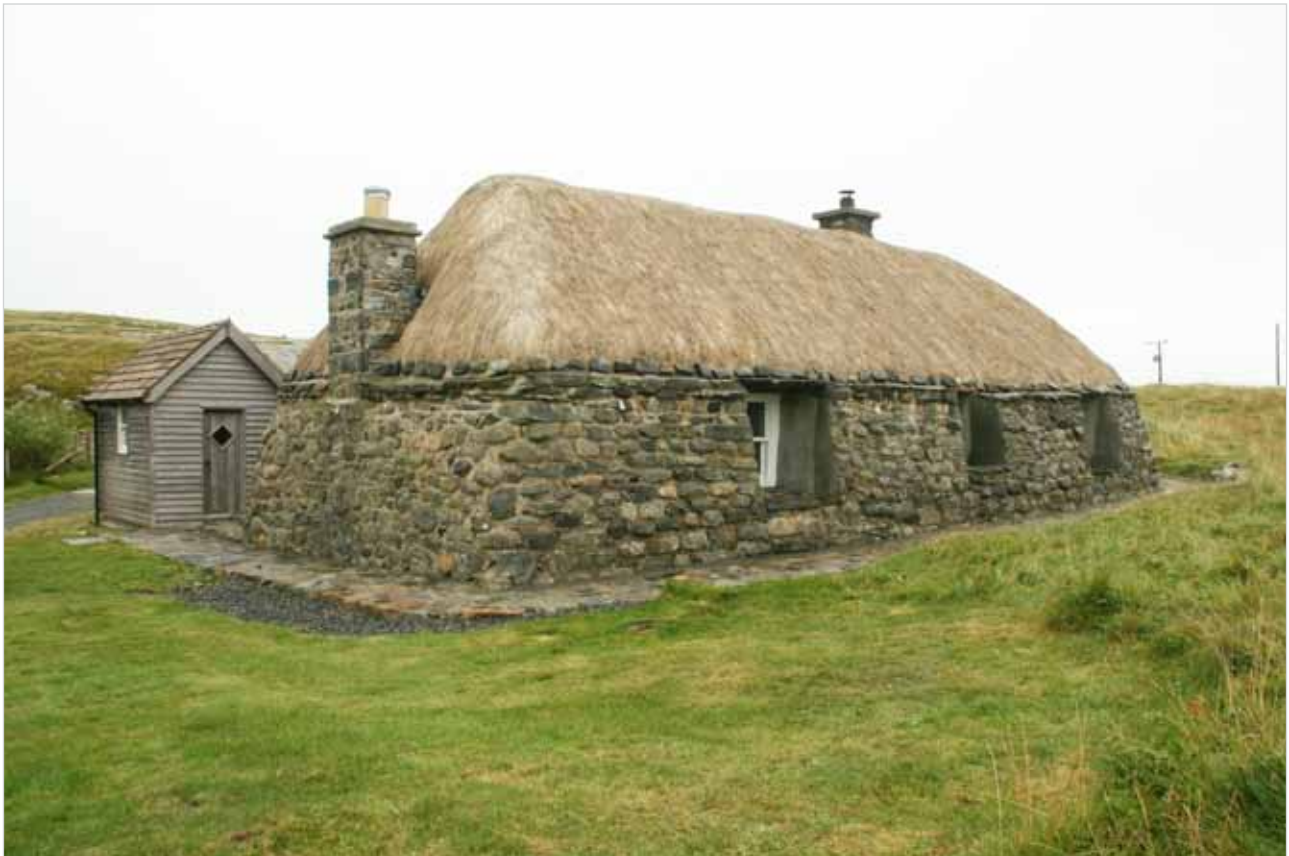
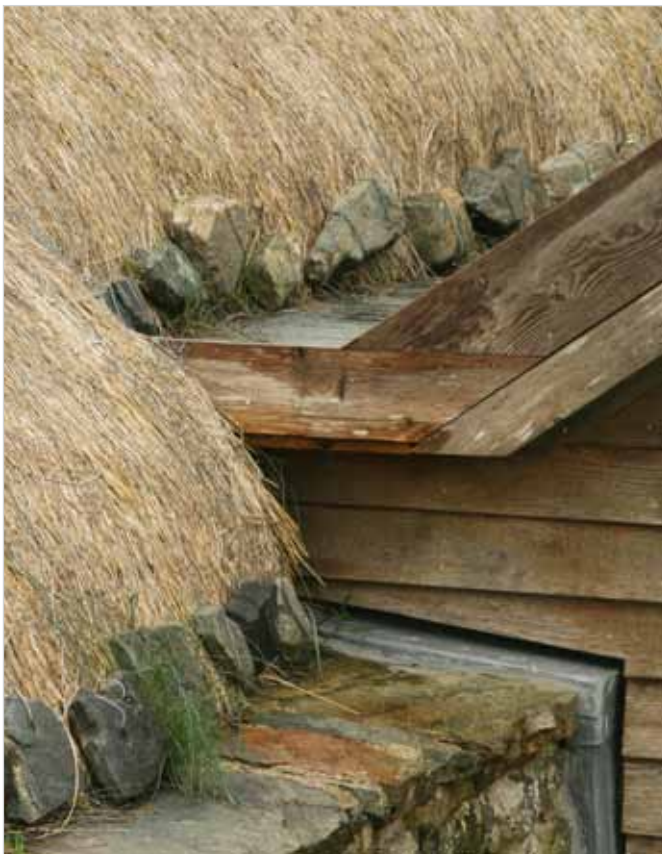
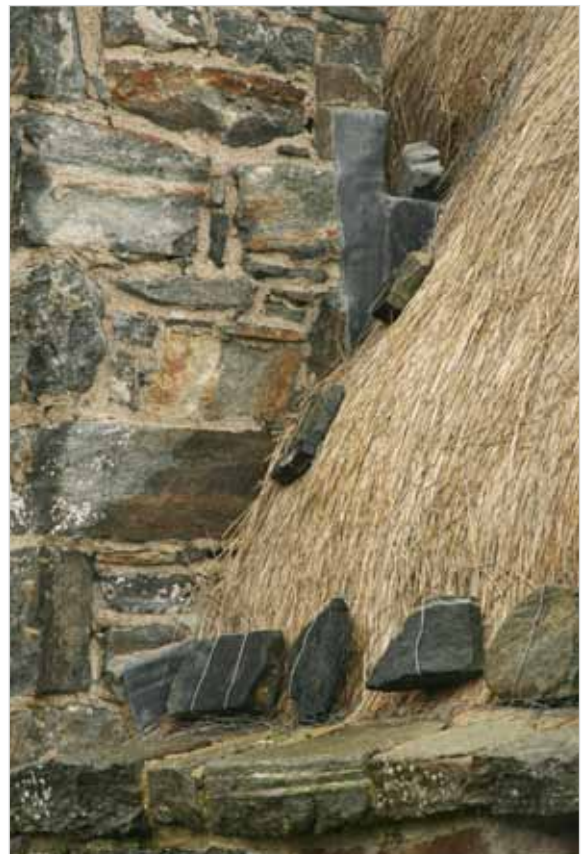
Laimrig Ruadh Thatched Cottage – Western Isles

marram ridge. The entire roof has been netted, weighted along the eaves, over the window openings and around

the porch extension by stones secured to the netting by wire.

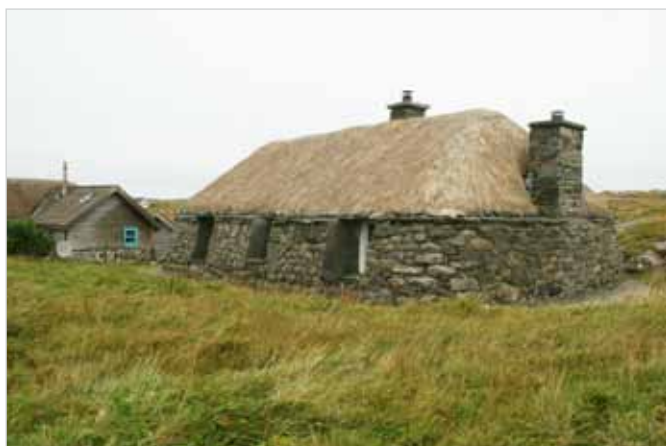
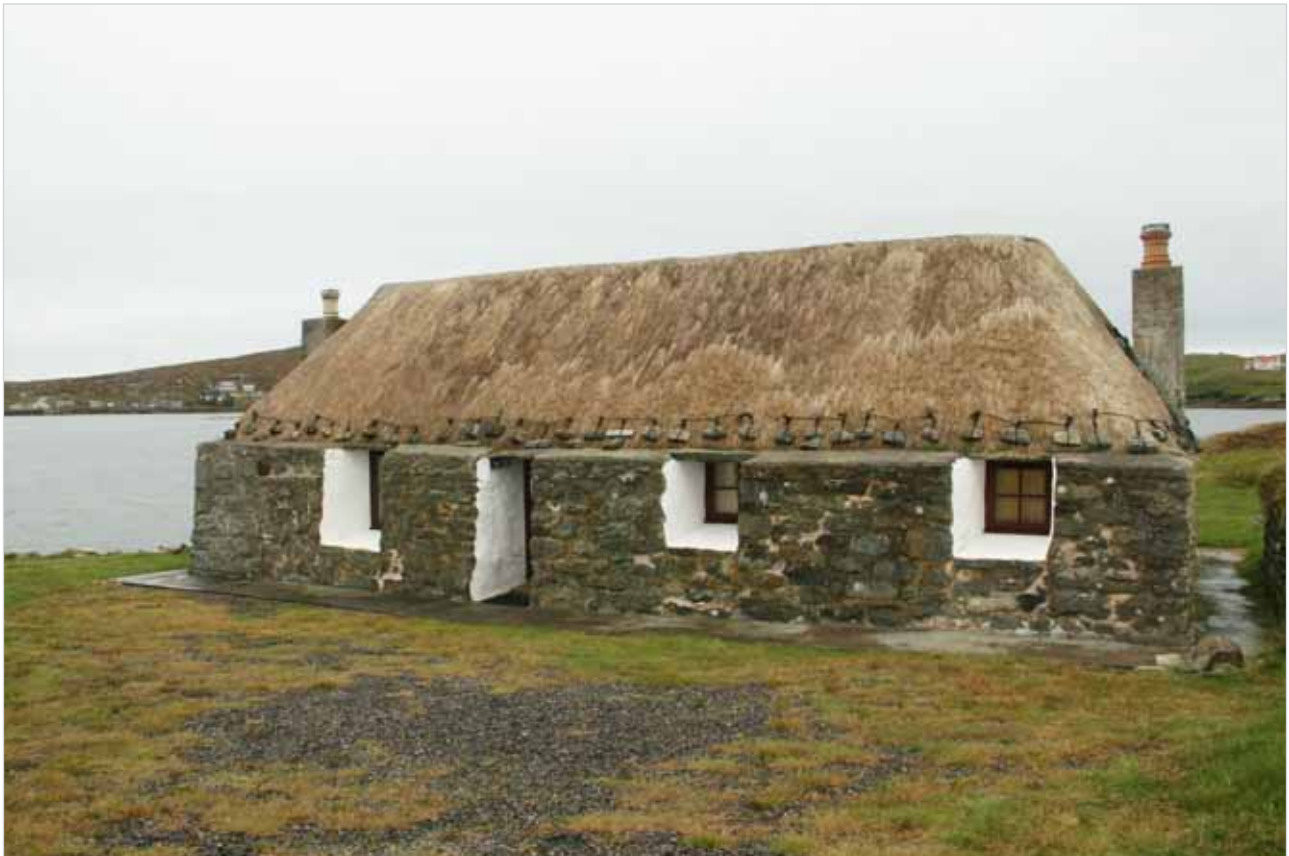
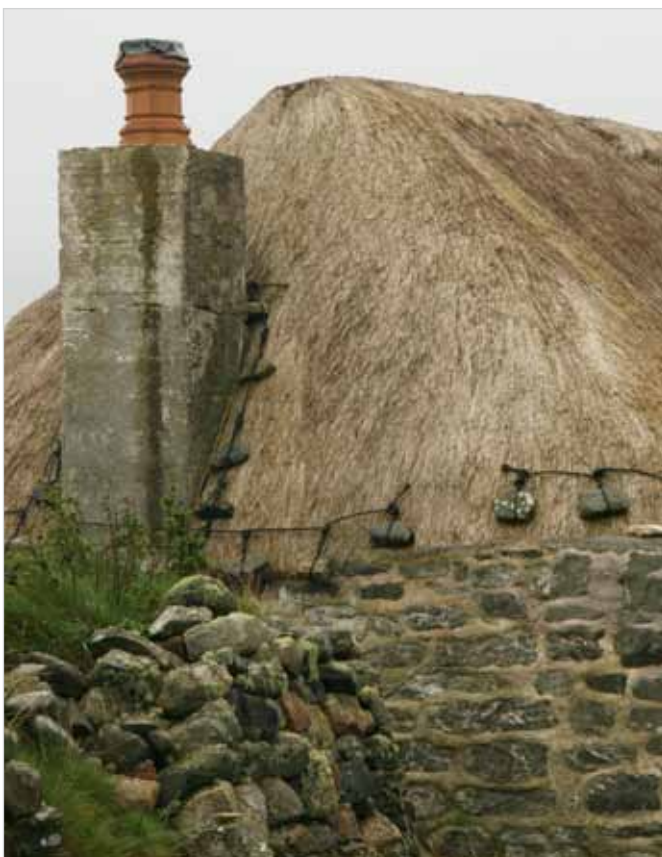
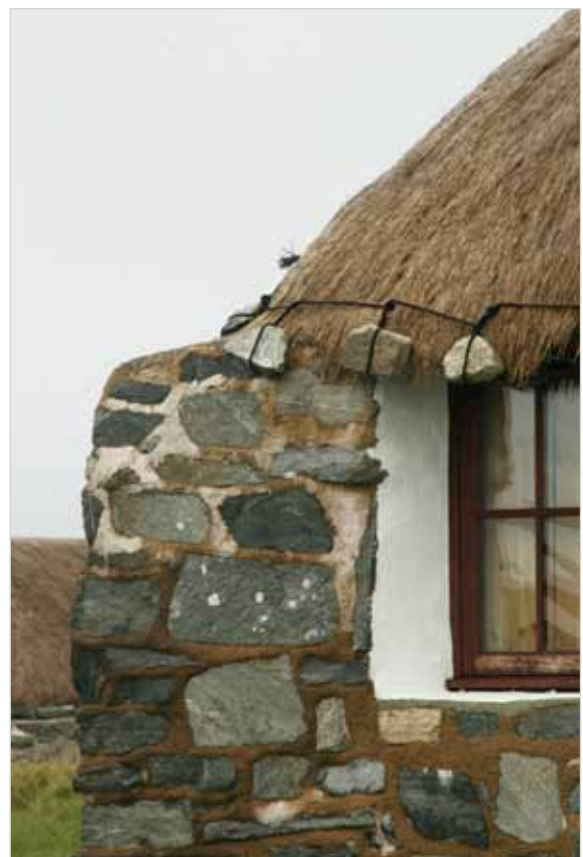
Laimrig Ruadh Thatched Cottage – Western Isles

Additional Notes: ..... Probably 19th-century cottage with modern porch addition to east, listed as having a  
..... 'muran thatch roof, secured with netting and ropes, stone and wooden weights over inner wallhead'. The modern  
..... porch extension has a slatted timber roof. The cottage is still thatched in marram and has a continuous marram  
..... ridge. The entire roof has been netted, weighted along the eaves, over the window openings and around the  
..... porch extension and chimney stacks at either end by stones secured to the netting by wire.

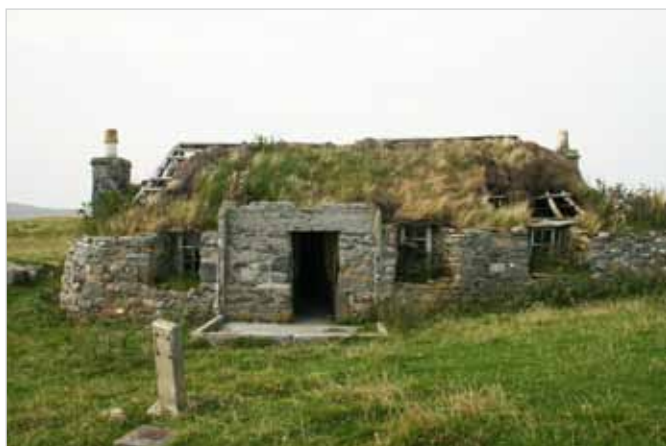
South West Cottage – Western Isles

Additional Notes: ..... South-west end cottage in a row of three, the middle and north-east cottages being roofless shells. The building's thatched roof is in a severe state of deterioration and the building has been on the Buildings at Risk (BAR) Register since 1998 (BAR reference number 1850). BAR inspections document the buildings' gradual decay since this time; however, it was recorded by BAR upon inspection in 2010 that Planning Permission and Listed Building Consent had been applied for for the renovation of the property. The current status of this planning application is unknown and the building remains in a derelict condition. There is some

..... marram thatch and turf underlay remaining on the roof, which is heavily overgrown with vegetation; however, there are large areas of thatch missing, exposing the roof structure and building's interior. There remains some visible evidence of the weighting stones and string, as well as the netting they would have once held in place.

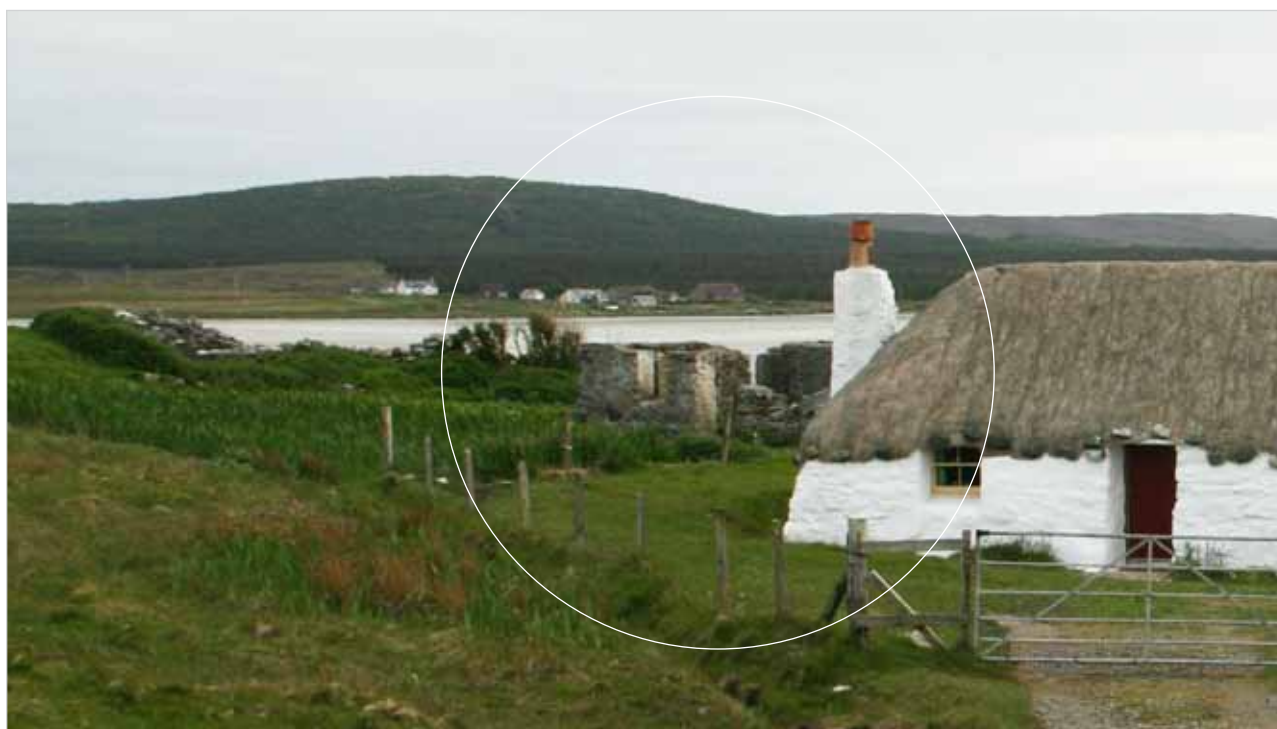
Address: Cottage to West of Struan Cottage

**Additional Notes:** ..... Probably late 19th-century cottage, listed as having a '*muran* thatch roof, secured above inner wallhead with stone weights'. The cottage is now a roofless ruin and has been on the Buildings at Risk (BAR) register since 2009 (BAR reference number 3767), at which time it was already recorded as being roofless. The listed building description should be updated accordingly, as well as the name of the building which states that the building is east of Struan Cottage, when it is in fact to the west.
